CARR-1321

Joseph Harnish Farm
Taneytown (vicinity)

Maryland Historical Trust State Historic Sites Inventory Form

Survey No. CARR-1321

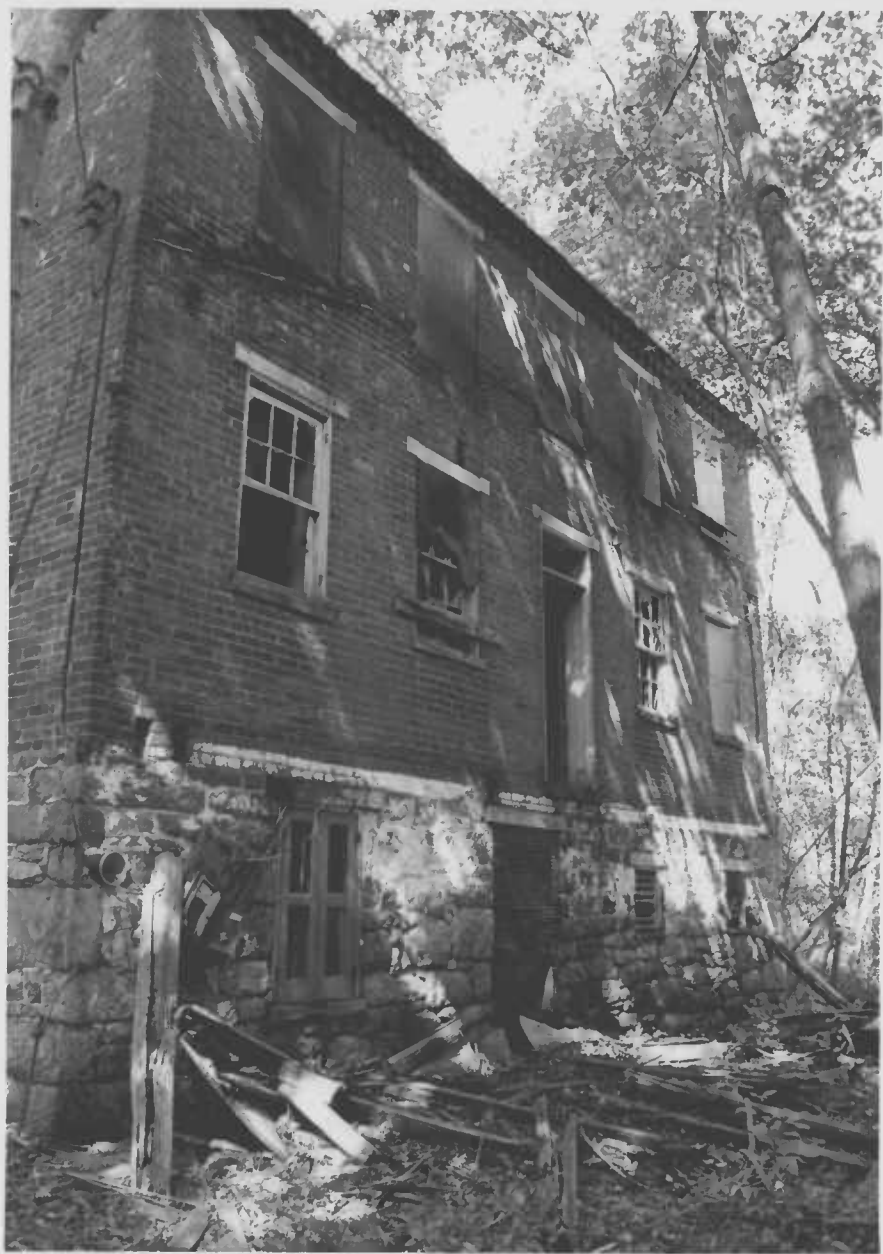
1/3

house - east elevation

The exposed cellar wall on the east elevation is only four bays. The south bay has a 6/6 sash with wood sill and wood lintel with corner blocks. It also has a pair of 2-panel wood shutters. North of this is a four-panel wood door with panelled jambs and a wood lintel with corner blocks. The two north bays have wood vents with louvers that are diamond in section. The first story has a center entrance with a four-light transom and an eight-panel door with two small lying panels at the top, two large panels, then two more small lying panels, and two square panels at the bottom. The door rails and stiles

are painted a medium grey, with the panels painted a light grey. There are ogee panel moulds. The doorway has a panelled soffit and jambs, and a brownstone sill. In the four flanking bays and the five in the second story are 6/6 sash with bullnose frames, wood sills, and wood lintels with corner blocks. The windows originally had shutters or blinds. The cornice consists of a brick dentil course. There is an interior brick chimney at each gable end.

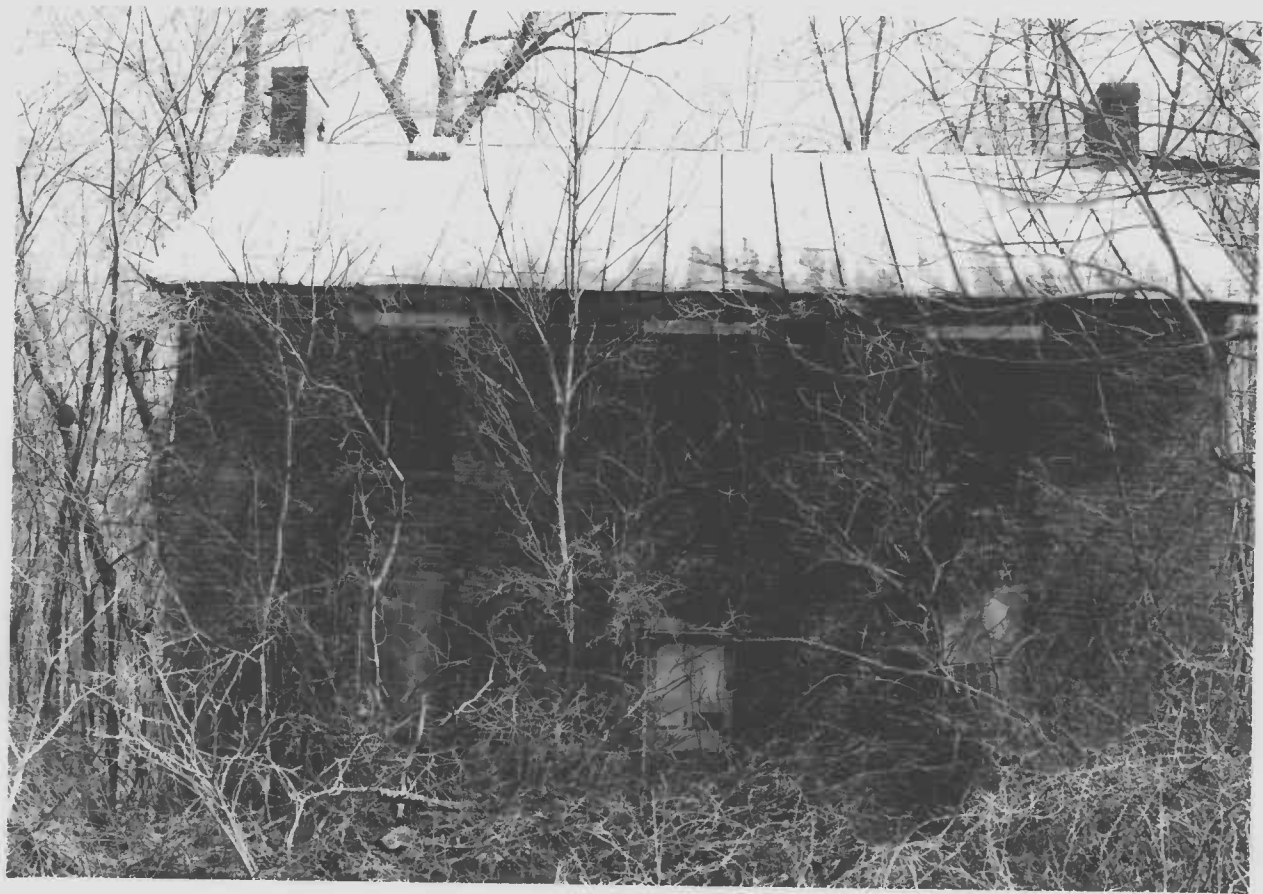
2/3

west elevation

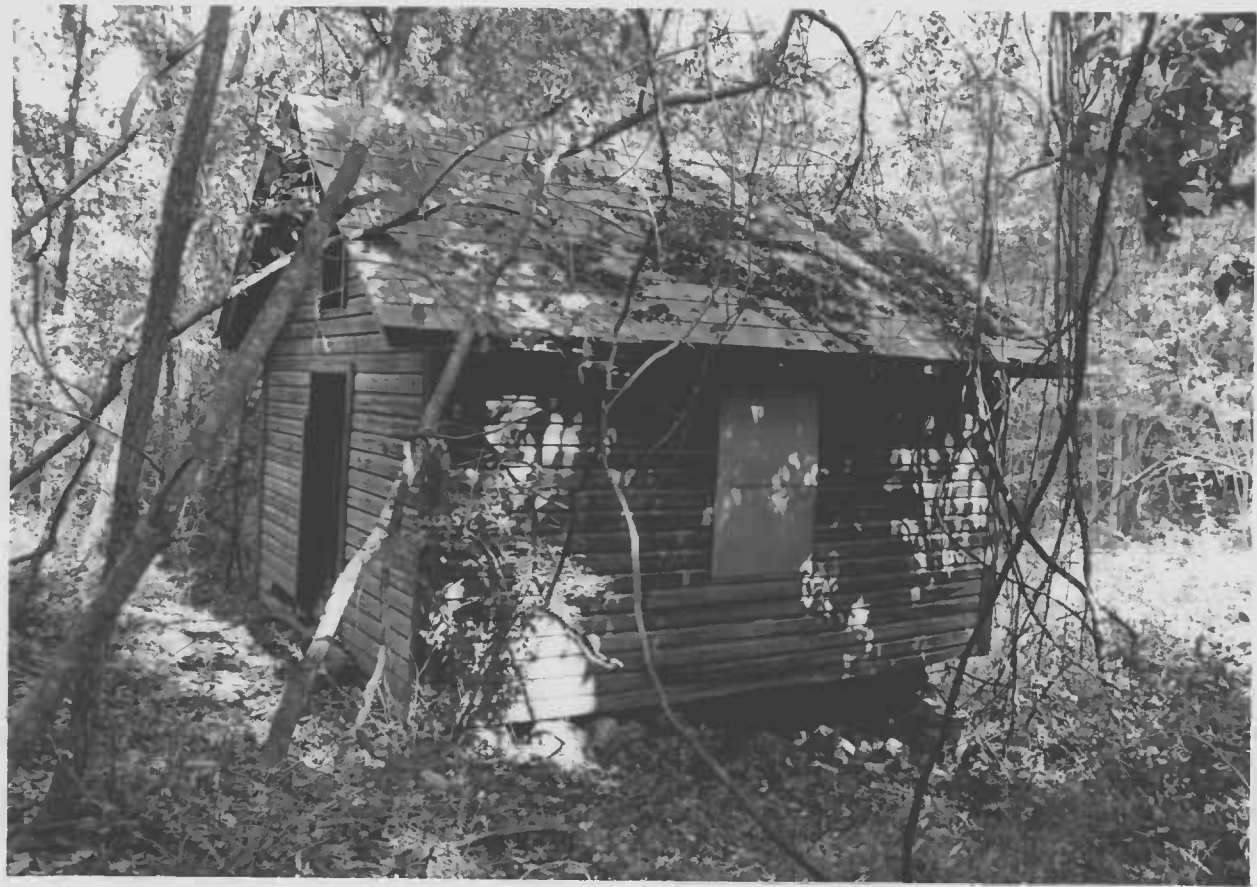
Summer Kitchen - west ; south elevations

About fifteen feet northeast of the house is the summer kitchen. It is a one-story frame structure on a rubble stone foundation that has partially collapsed. The building has German siding and a gable roof with slate. The west elevation has a door in the center of the first story, with a window opening in the gable end above. There is a boarded-up window on both the north and south elevations. The internal brick fireplace on the east end has suffered significant collapse. The frame of the structure is built of circular-sawn 2 x 4 studs, with clamps let into them that then support joists for an attic. The attic was probably only partially floored for storage.
